U.S. Chemical Safety and Hazard Investigation Board

Three Catastrophic Hydrogen Fluoride Incidents at Honeywell Geismar

Geismar, Louisiana | No. 2023-02-I-LA

Investigation Report

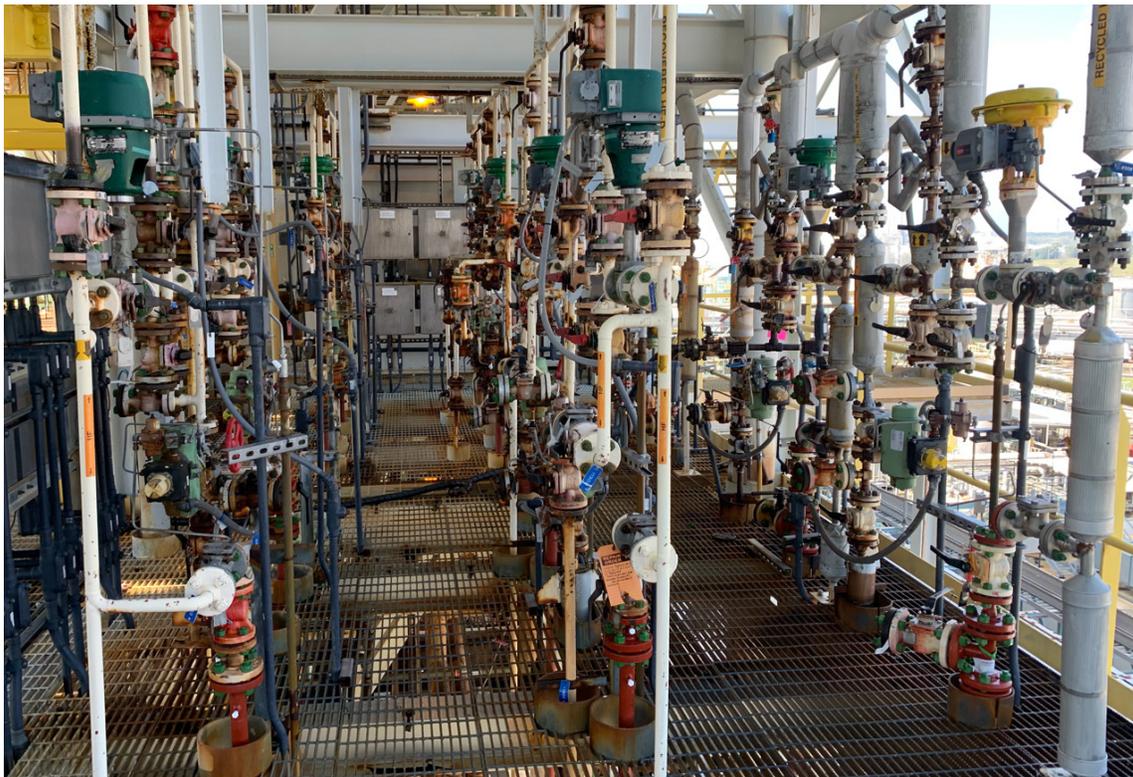
Figure 3. Photo of the D reactor Fresh HF (left), Recovered HF (center), and Recycle HF (right) feed stations.^a (Credit: CSB)

^a Figure 3 shows the locations of both the 2021 and 2024 incidents. The 2021 incident occurred on the D reactor recycled HF feed station, shown on the right of Figure 3. The 2024 incident occurred on the D reactor fresh HF feed station, shown on the left of Figure 3.

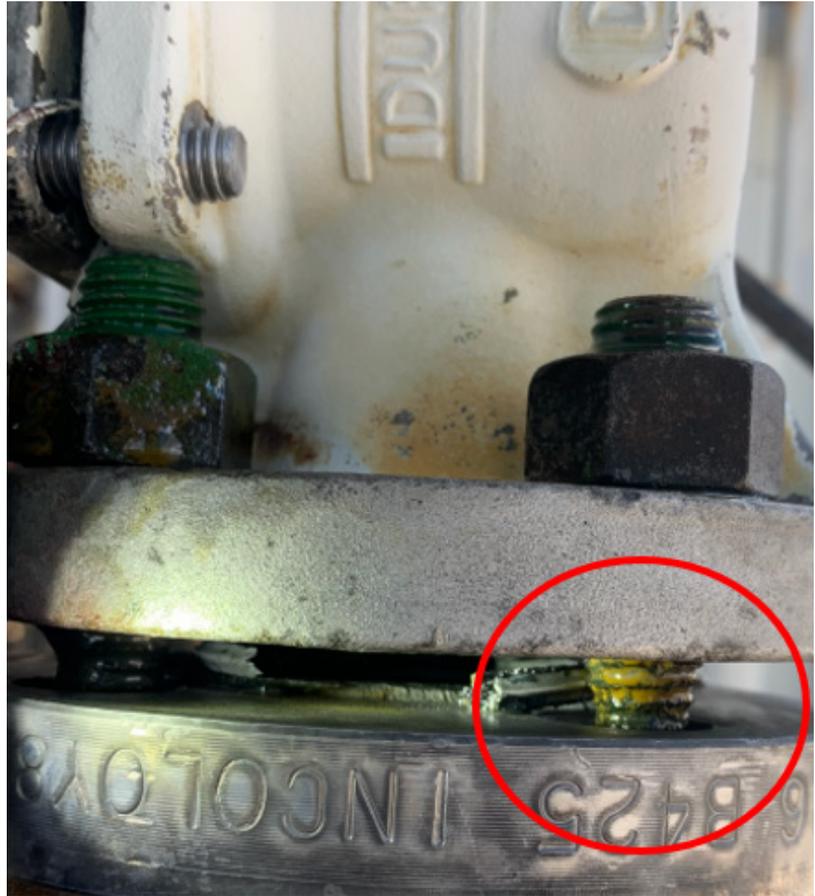
Figure 7. Photo of the flange assembly as found after the incident, showing the stud corrosion observed by the field operators prior to the release. (Credit: Honeywell, annotated by CSB)

The fastening studs were constructed of A193 Grade B7M and had a nominal diameter of 0.50 inches. After the incident, Honeywell contracted Stress Engineering Services (“SES”) to conduct metallurgical examination of the flange assembly, including the gasket and fasteners. SES measured diameter loss between 0.020 and 0.060 inches among the fastening studs installed in the incident flange. A picture of one of the corroded fastening studs is shown in **Figure 10**.

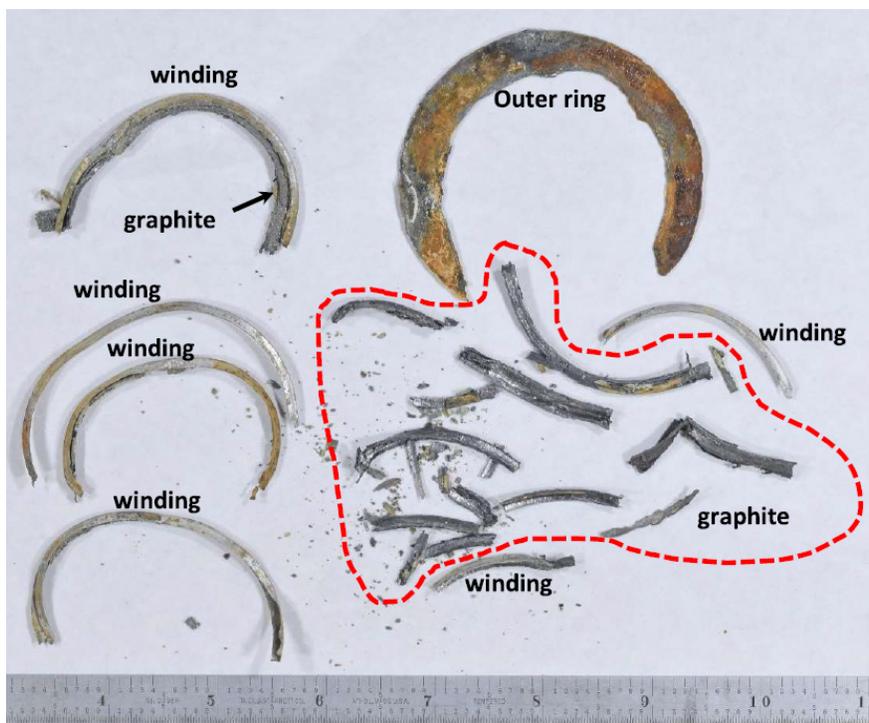
The release was caused by the failure of a spiral wound gasket.^c The gasket was constructed with 304 stainless steel windings and graphite filler, which, according to Honeywell, was appropriate for the process material and conditions. A photo of the remnants of the failed gasket is shown in **Figure 9**.

Figure 9. Photo of the failed spiral wound gasket remnants. (Credit: Honeywell via Stress Engineering Services, annotated by SES)

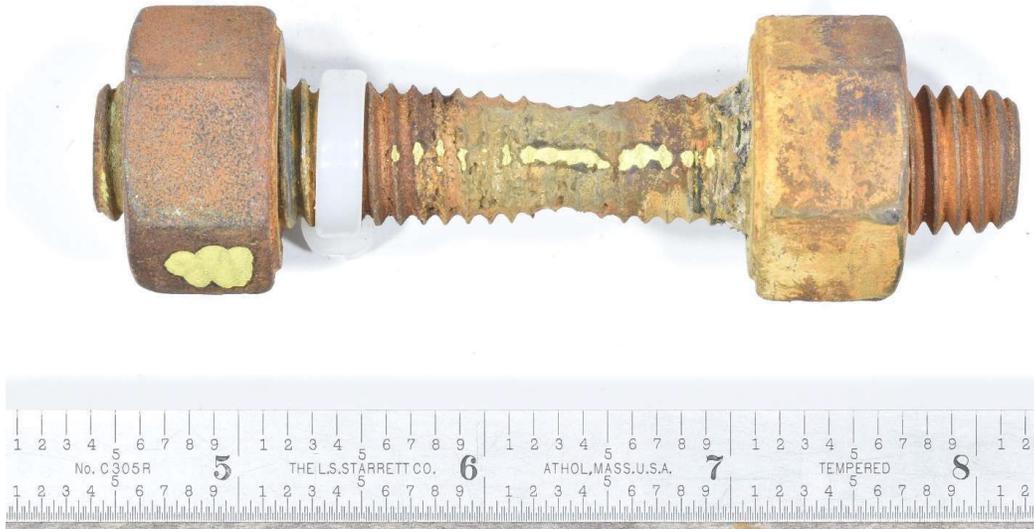
Figure 10. Post-incident examination photo of a corroded stud installed in the incident flange. (Credit: SES)

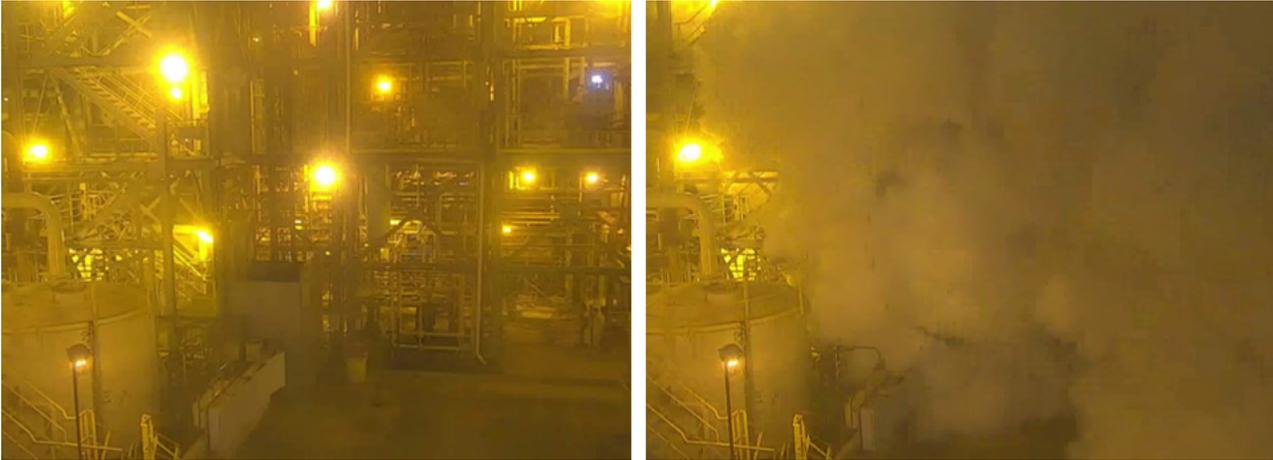
At 7:03 p.m. on January 23, 2023, Honeywell Geismar began restarting the 245 unit after the site experienced an unrelated utility outage. Operations personnel established feed to the distillation column at 7:16 p.m. At 8:12 p.m., the reboiler shell suddenly and catastrophically ruptured when the reboiler shell thinned to the point at which it could no longer contain the operating pressure (**Figure 17**).

Figure 17. Surveillance images immediately before (left) and four seconds after (right) the reboiler rupture. (Credit: Honeywell)

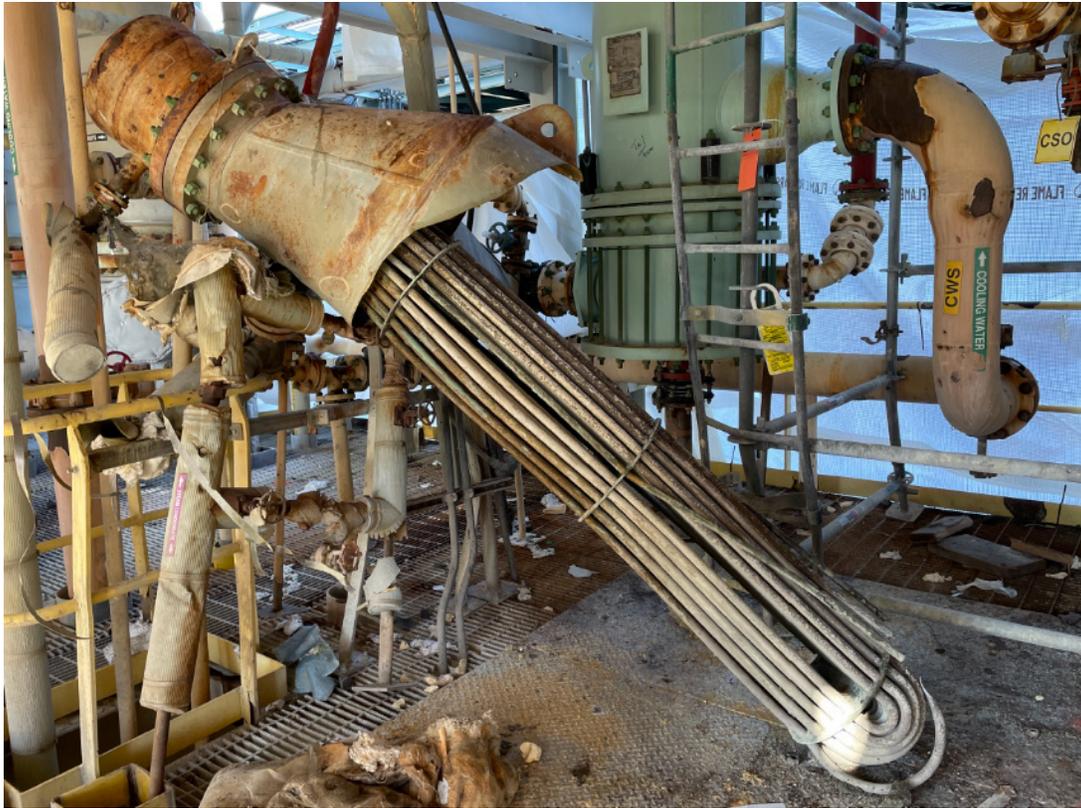
The reboiler shell ruptured into at least nine fragments, which were propelled up to 35 feet away. The largest fragment contained the tube side head, the complete tube bundle, and the conical section of the shell. This fragment is pictured below in **Figure 18**. The debris from the explosion was largely contained by the nearby piping and equipment collocated on the same platform as the reboiler.

Figure 18. Post-incident image showing the remnants of the reboiler. (Credit: Honeywell)

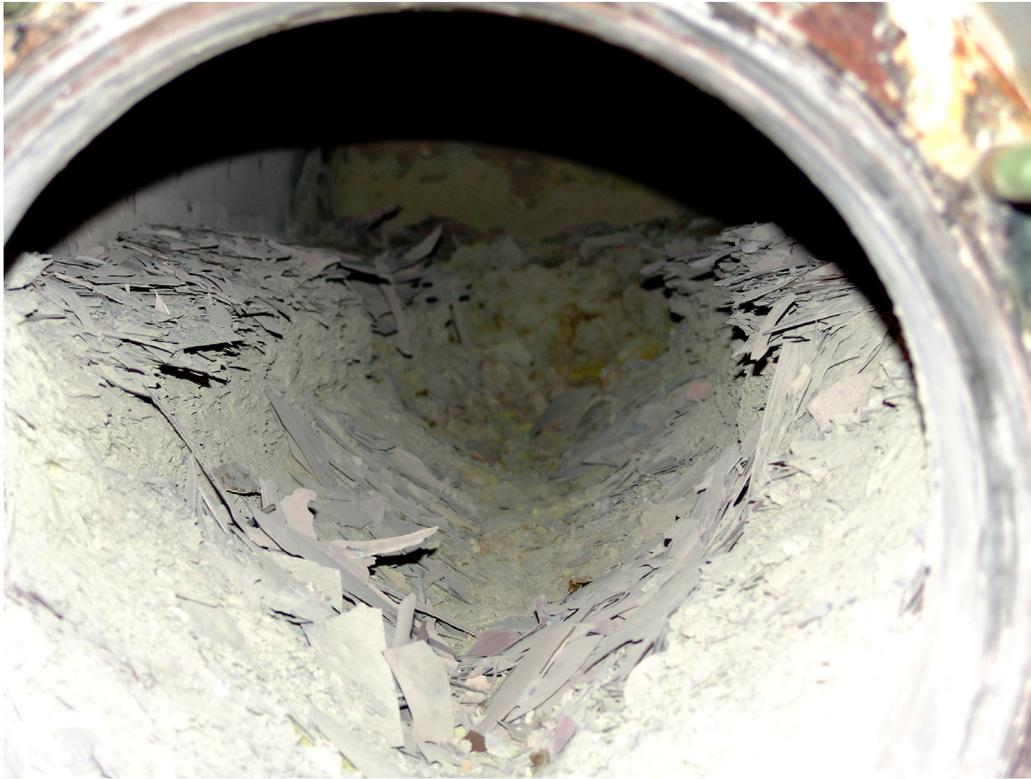
In May 2005, Honeywell conducted an internal inspection of the reboiler shell and found it filled with corrosion solids and debris, pictured below in **Figure 19**.

Figure 19. Picture of the inside of the reboiler shell, taken during a May 2005 internal inspection. (Credit: Honeywell)

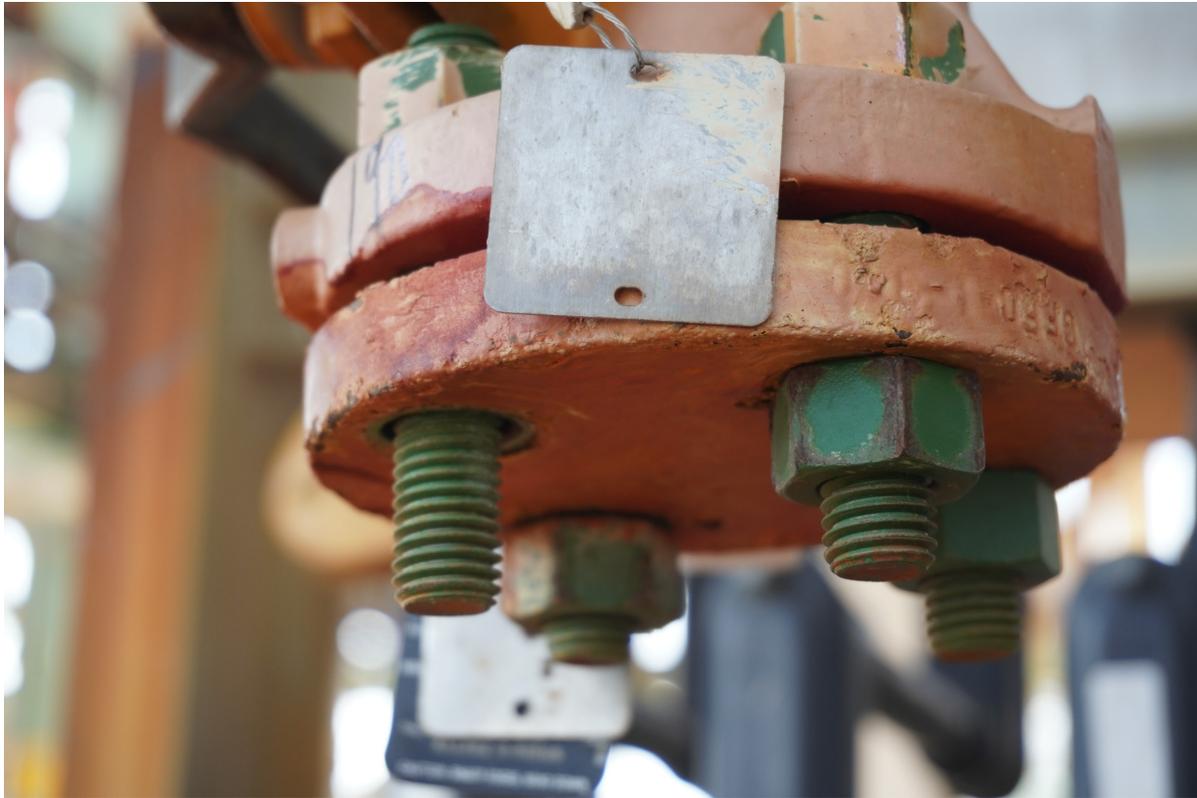
Figure 30. Blind flange as found after the incident.^a One nut was removed (foreground left) and another (background left) was loosened to within two to three threads. (Credit: CSB)
