U.S. Chemical Safety and Hazard Investigation Board

Three Catastrophic Hydrogen Fluoride Incidents at Honeywell Geismar

Geismar, Louisiana | No. 2023-02-I-LA

Investigation Report

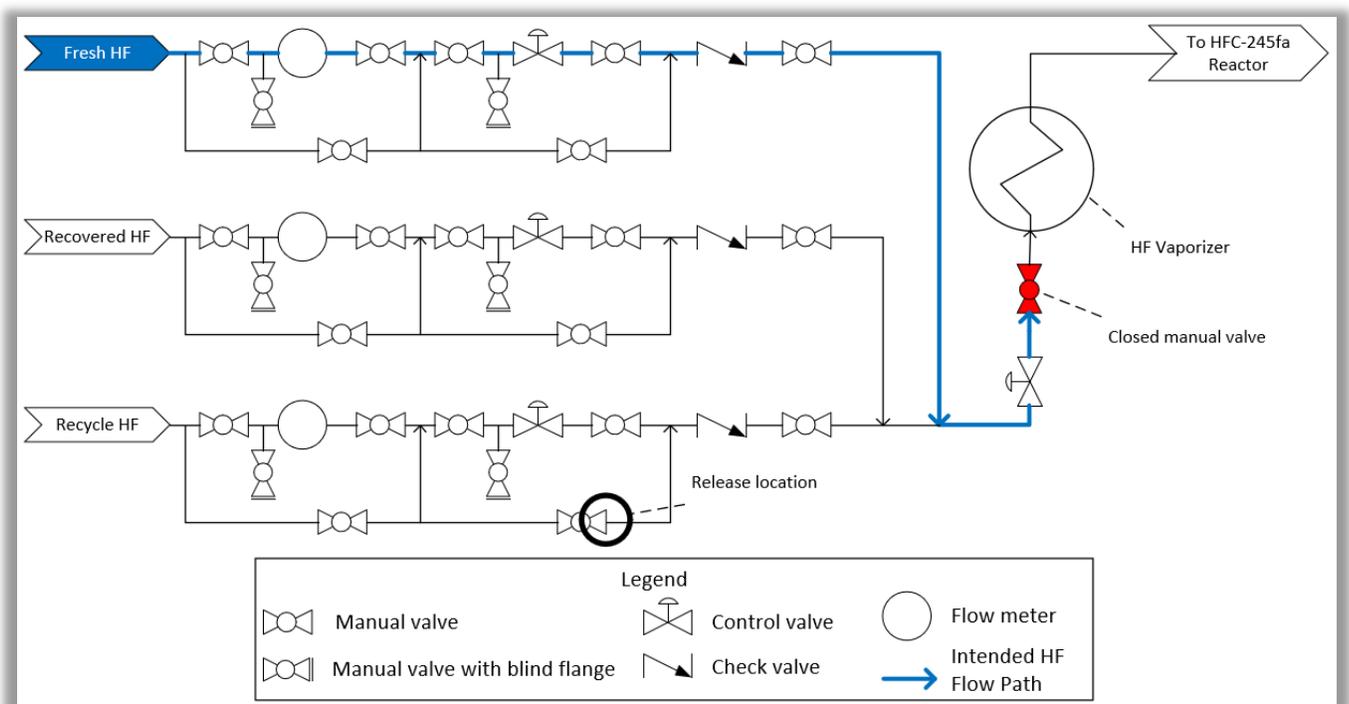
After the Board Operator (from the control room) and Field Operator 1 made various unsuccessful operational moves at the fresh HF feed station to attempt to resolve the no-flow condition to the vaporizer, the Board Operator requested that Field Operator 1 check the alignment of the manual block valve on the combined HF feed to the vaporizer. Unbeknownst to either the Board Operator or Field Operator 1, the manual block valve immediately upstream of the vaporizer was closed because reactor D had not been made ready to return to service^a (**Figure 6**).

Figure 6. Intended flow path of HF during the attempted startup of HFC-245fa reactor D. (Credit: CSB)

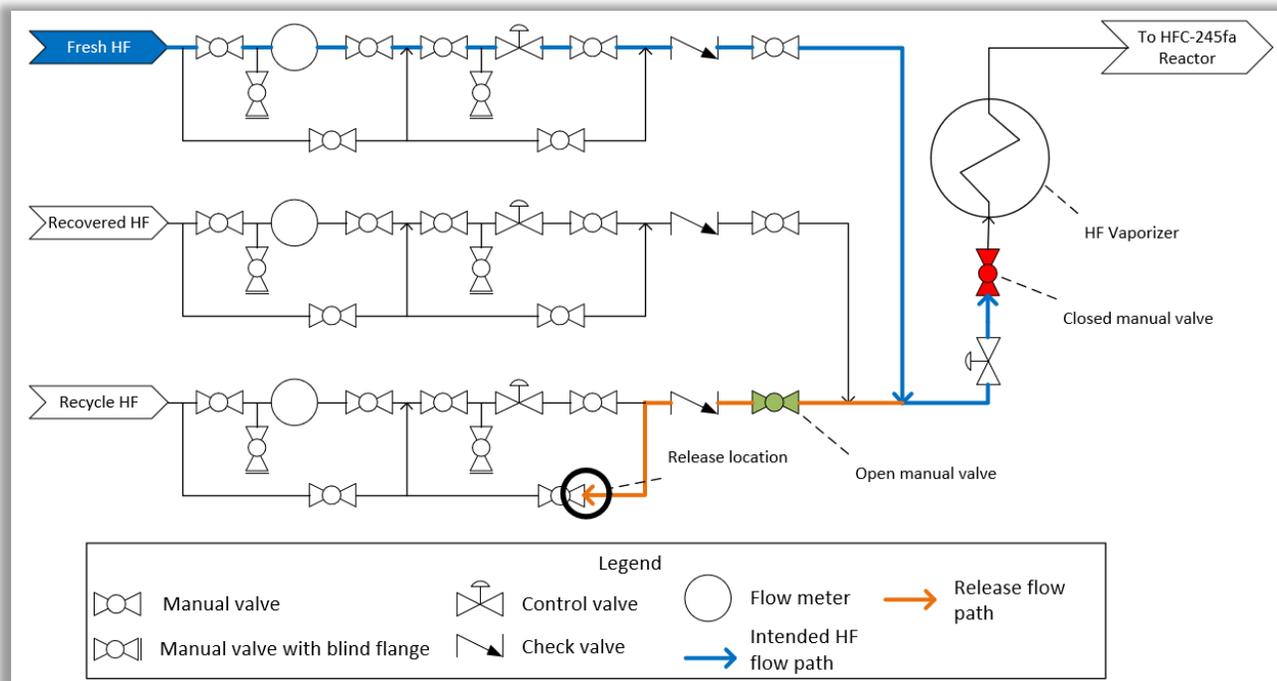
At this point in the startup, the recycle HF feed station should not have been pressurized, and there should have been no HF flow to this feed station. Assuming that the HF was flowing from the upstream direction, Field Operator 1 went to check an upstream block valve to ensure that it was closed. The operators were unaware that HF was backflowing from the downstream direction because of the closed valve on the HF inlet to the vaporizer (**Figure 8**).

Figure 8. Simplified diagram showing the release flow path during the incident. (Credit: CSB)

Honeywell investigated the incident and found that the cause of the no-flow condition to the D reactor vaporizer was a closed manual block valve immediately upstream of the vaporizer; the same valve that the Board Operator had asked Field Operator 1 to check before Field Operator 1 detected the HF leak from the recycle HF feed station. Honeywell isolated the vaporizer in preparation for the planned outage, but the vaporizer was never placed back into service prior to the startup. The valve was found locked closed. Honeywell determined that the closed manual valve caused the fresh HF to backflow into the recycle HF feed station through an open manual valve and a check valve^a to the release point (**Figure 8**).^b

On the morning of the incident, Honeywell attempted to start up reactor D after a planned unit maintenance outage. Leading up to the outage, reactor D and its associated equipment, including the vaporizer, were isolated and locked out. The D reactor vaporizer was not subsequently unlocked and valved back into service prior to the startup attempt. As a result, the manual valve on the HF inlet to the vaporizer remained locked closed during the startup attempt, which caused HF to backflow through an open manual valve on the downstream side of the recycle HF feed station, through a check valve that had failed, and to the incident flange (**Section 2.3; Figure 8**).

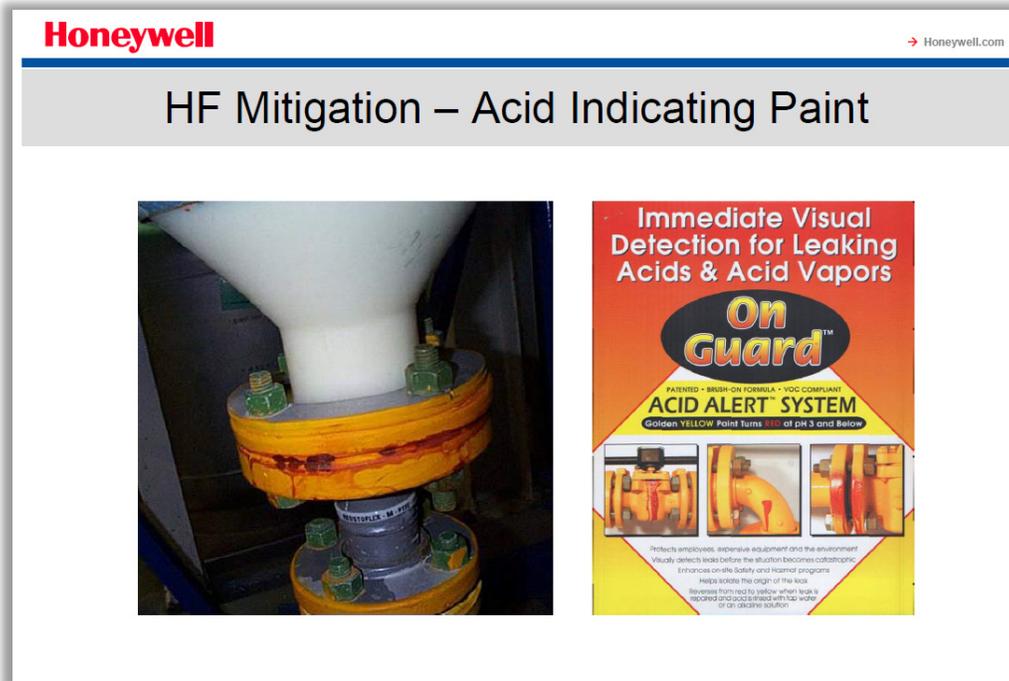
Figure 14. Slide from a 2009 presentation Honeywell made to the CSB, advocating for the use of acid indicating paint. (Credit: Honeywell)

On its website, Honeywell purports to be “the leader in HF [...] safety and handling training” and offers various training and consulting services concerning the use of HF [19]. Despite marketing itself as a leader in the safe use of HF, and despite advocating for practices such as the use of acid indicating paint to its customers and to the CSB, Honeywell did not use acid indicating paint in its own 245 unit. Honeywell did not begin using the paint in the 245 unit until after a Honeywell operator was fatally injured by an HF leak in the October 2021 incident that could have been prevented by the use of the paint.

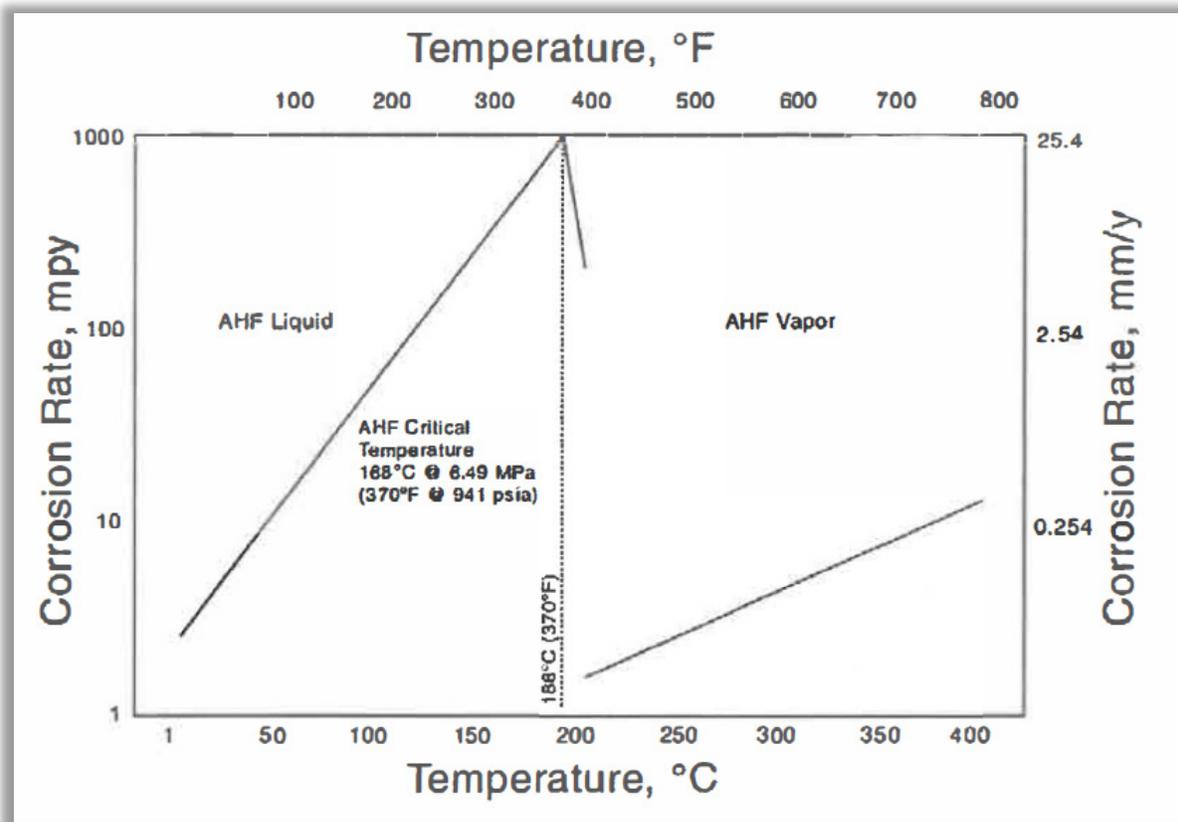
Figure 20. Corrosion rates^a of carbon steel in anhydrous HF (abbreviated as AHF in the figure) service over a range of temperatures. (Credit: AMPP [5, p. 12])

Figure 20 shows that at the temperatures at which Honeywell operated the reboiler, Honeywell could expect a corrosion rate of roughly 30-80 mils^b per year (mpy). Honeywell Geismar was generally aware of the data and

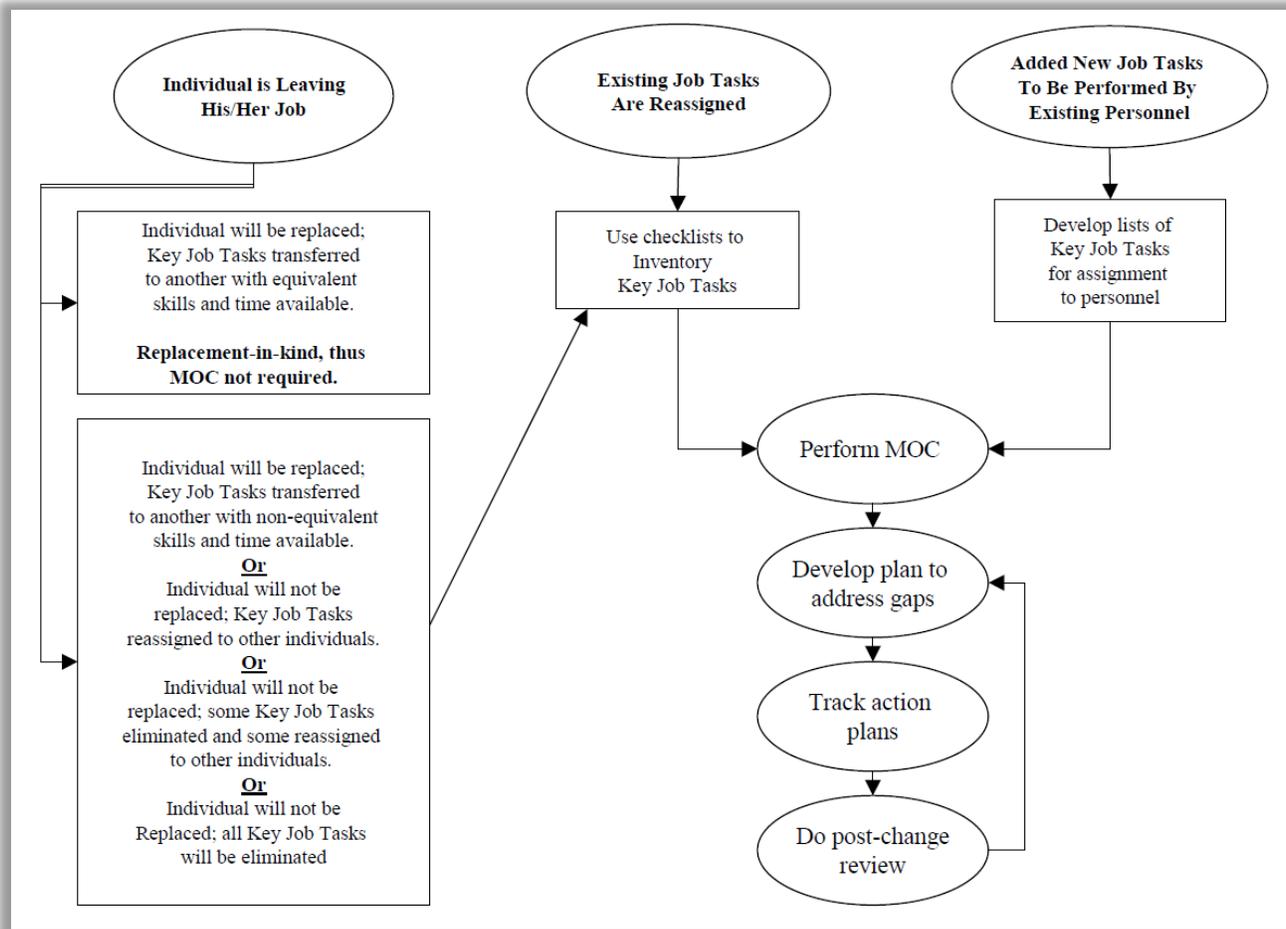
Honeywell Geismar’s MOOC procedure required the user to first determine whether an MOOC evaluation was required, or whether a given personnel change was a “replacement in kind.” Users of the procedure were directed to a flowchart (**Figure 22**) to aid in determining whether an MOOC evaluation was necessary.

Figure 22. Honeywell flowchart to determine whether MOOC analysis was required. (Credit: Honeywell)

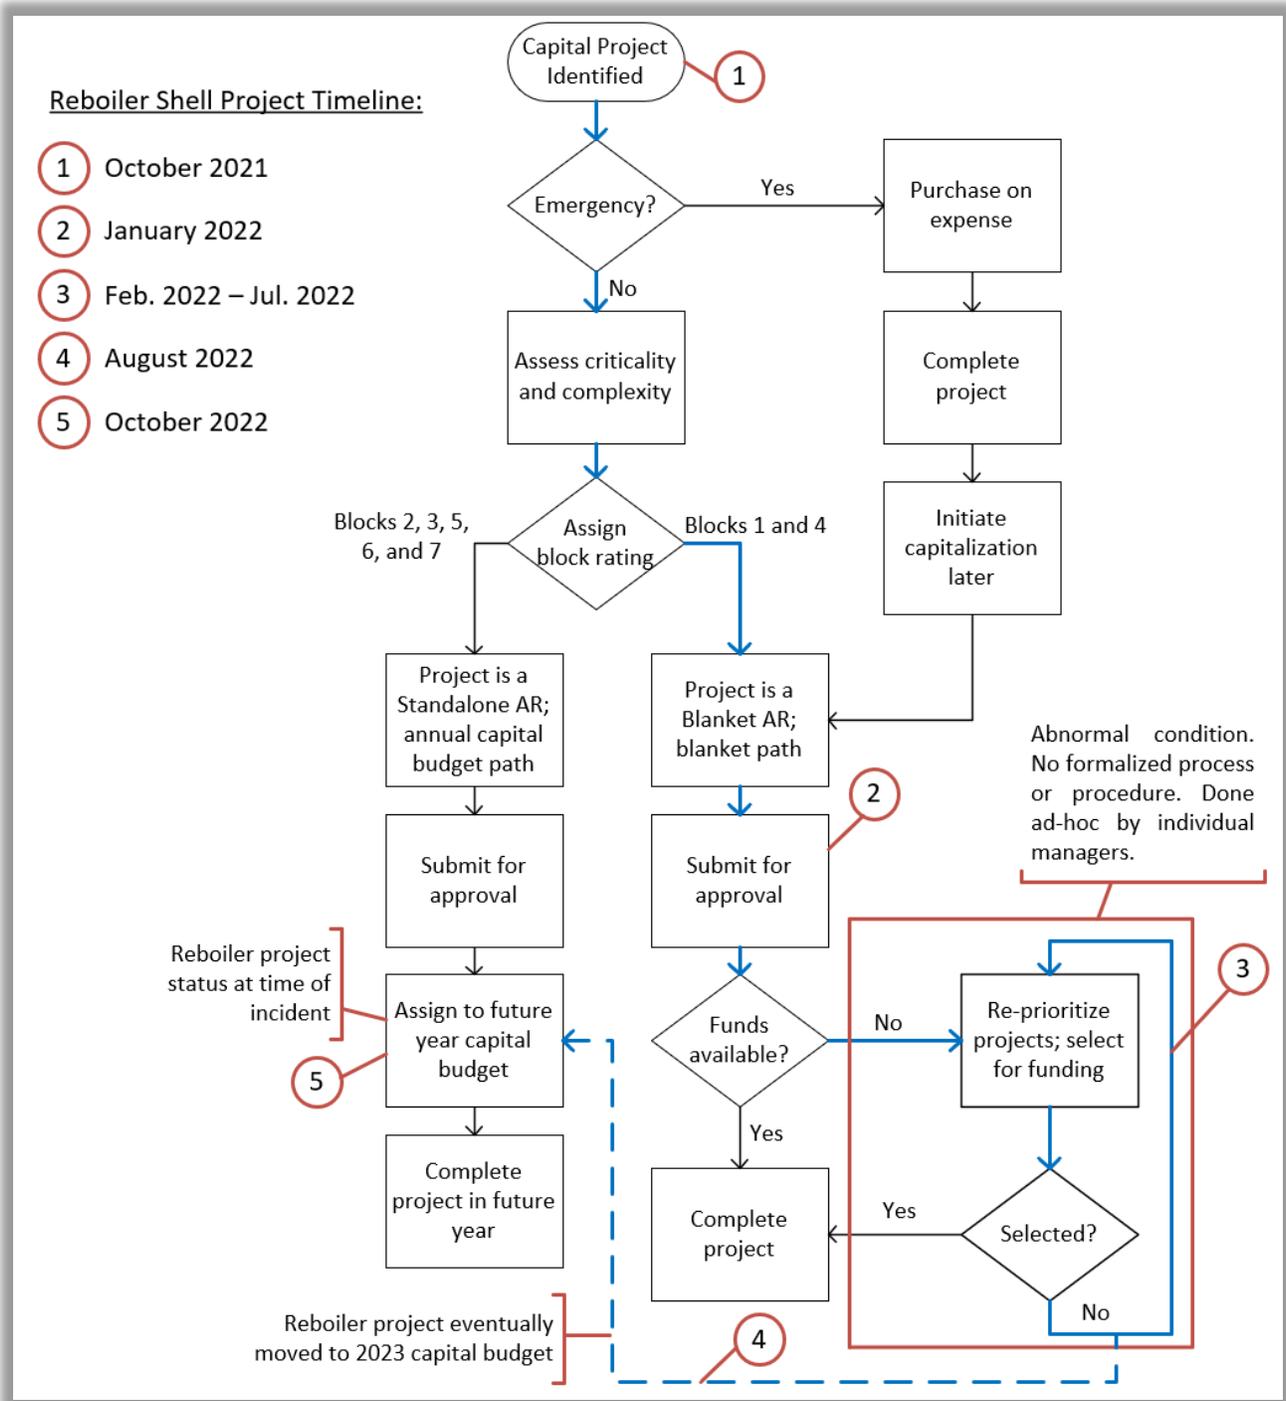
The site managers who were asked to re-prioritize the project list were the same managers who told the CSB that they were unaware of the reboiler project's urgency, despite some of them having approved the project themselves. Further, project re-prioritization was done on an ad-hoc basis via email, without any formalized policy, procedure, or guidance on how to do so or which factors should be considered. **Figure 26** below shows a graphical representation of how Honeywell Geismar's capital project management systems functioned with respect to the reboiler project.

Figure 26. Flowchart showing how the reboiler project was managed. The steps through which the reboiler project progressed are highlighted with blue arrows. (Credit: CSB)

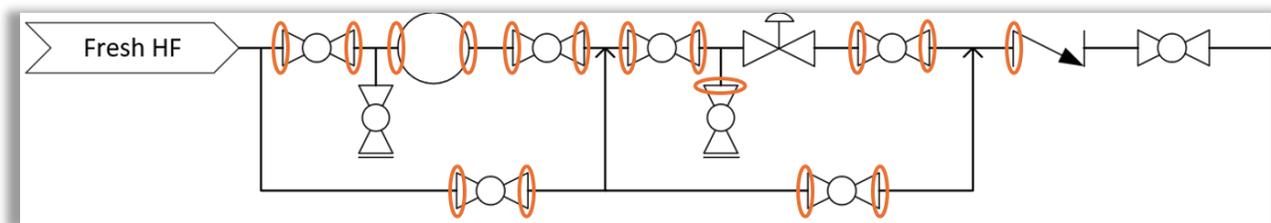
By June of 2024, the progress of the effort to replace spiral wound gaskets reached the D reactor fresh and recovered HF feed stations. At the time of the incident, two contract pipefitters were replacing gaskets in the D reactor fresh HF feed station. An excerpt of the scope of work involved in this incident is shown in **Figure 27**.

Figure 27. Excerpt of the incident job scope. In-scope flanges and gaskets are circled in orange. (Credit: CSB)

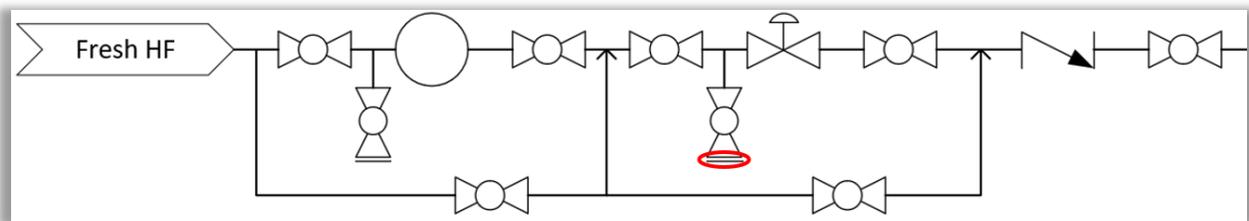
As the two workers proceeded through the work, one of them loosened the blind flange^a on one of the two bleed valves, as depicted in **Figure 29** and pictured in **Figure 30**:

Figure 29. Simplified drawing of the fresh HF feed station. The release location is circled in red. (Credit: CSB)

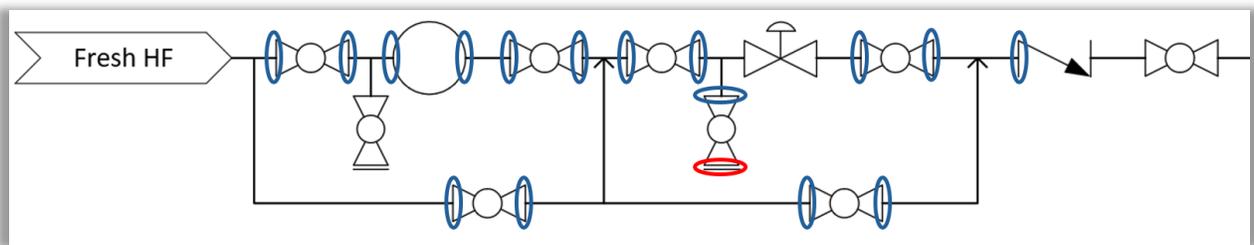
Figure 31. Partial excerpt of the incident job scope. In-scope flanges and gaskets are circled in blue. The blind flange from which the HF released was not in scope and is circled in red. (Credit: CSB)

As Honeywell concluded in its investigation of this incident, the blind flange connection from which the HF released was not within the job scope. Yet, from a safety perspective, whether that flange was in or out of scope is ultimately irrelevant; the valve was within the bounds of the lockout and should have been cleared of hazardous energy.

Moreover, even though the bottom blind flange was not in scope, the gasket within the top side flanged connection of the incident valve was in scope (as shown in **Figure 31**). Replacing this gasket would have required workers to disconnect the top side flanged connection of the incident valve in order to access the gasket. Doing so would have required the workers to handle the valve (which contained trapped HF) while they were wearing insufficiently protective PPE (because they removed their Level B PPE, believing the piping was empty). This would have been an unsafe practice regardless of whether the bottom side blind flange was in or out of scope. The best way to ensure that the trapped HF did not escape from the valve and injure a worker would have been to ensure that there was no trapped HF.

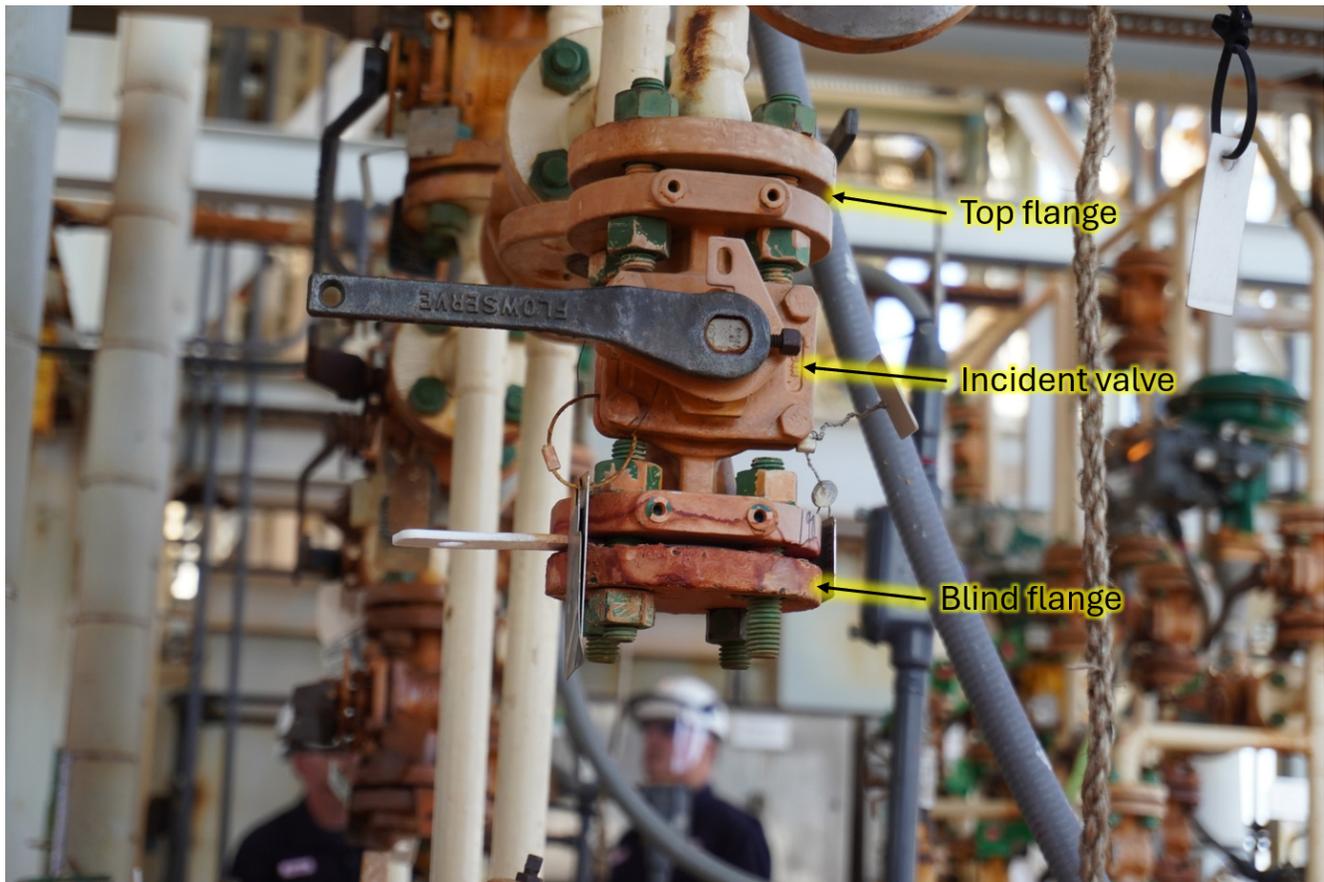
Notably, the incident valve and blind flange assembly meet all four of those descriptions, as it was a local low point on a horizontally oriented section of piping, it constituted a dead leg,^a it contained a closed valve, and it contained an installed blind. During Honeywell's preparation for maintenance, leaving the incident valve closed prevented it from being cleared during the nitrogen purge and vacuum steps of the clearing procedure. Had the valve been opened during this point of the preparation process, the valve likely would have been cleared of HF prior to the incident, and the worker would not have been exposed to HF when he mistakenly loosened the out-of-scope blind flange. A photo of the valve as found in the closed position is shown in **Figure 32**.^b

^b Note the orange-tinted acid indicating paint on the body of the valve and on the top and bottom flanges. On the bottom flange, the paint has turned red, indicating that it has been exposed to HF vapors. See **Section 2.4.2.1** for a discussion of acid indicating paint.

Figure 32: As-found condition of the incident valve showing that the valve was in the closed position at the time of the incident. (Credit: CSB)

The CSB concludes that Honeywell did not ensure that all piping within the bounds of the lockout was free of hazardous energy. The incident valve should have been cleared of HF as part of Honeywell's preparation for the maintenance work. Doing so would have prevented the HF release and the serious injury.
